CITY OF MIAMI BEACH

OFFICE OF CAPITAL IMPROVEMENT PROJECTS
FEASIBILITY STUDY

FOR THE
BYRON CARLYLE THEATER

January 2006

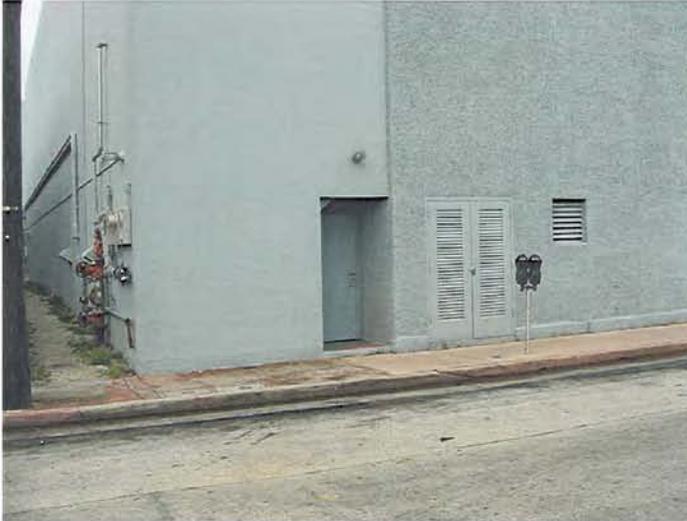
4.1 South east corner of building location of main electrical and mechanical room.

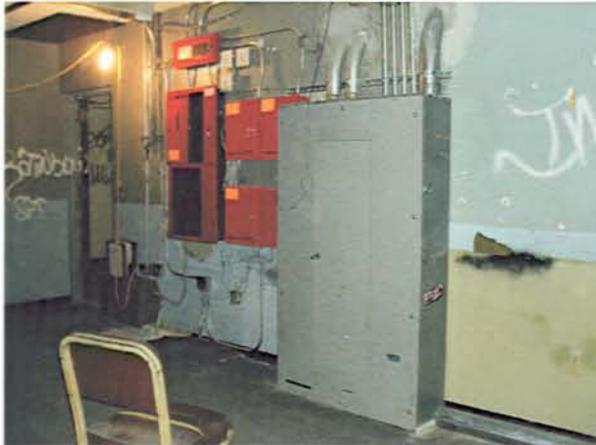
7.- **EXISTING CONDITIONS - Fire alarm panel – Upgraded in 2004 renovation to the East side. Second floor – old projection room on the east wall.**

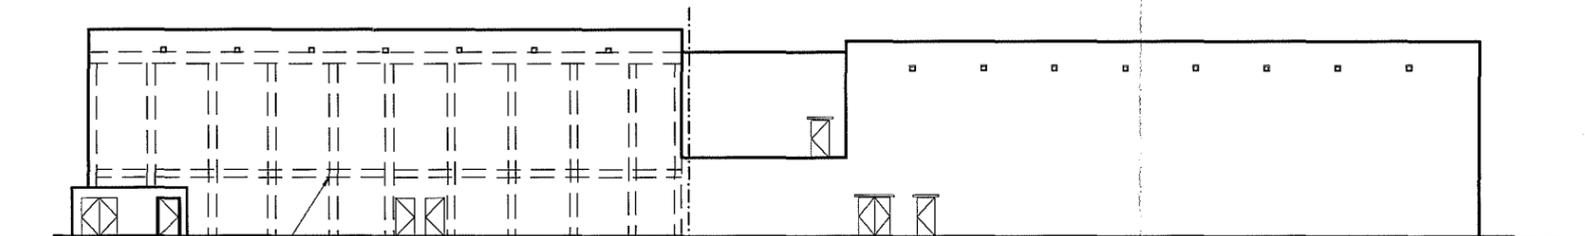
EXISTING TIE BEAM AND TIE COLUMNS
