CITY OF MIAMI BEACH

OFFICE OF CAPITAL IMPROVEMENT PROJECTS
FEASIBILITY STUDY

FOR THE
BYRON CARLYLE THEATER

January 2006

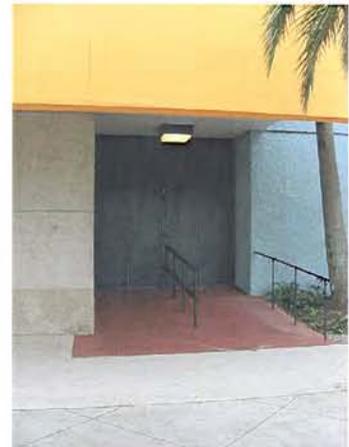
2.13 - Ramp and railing does not meet ADA.

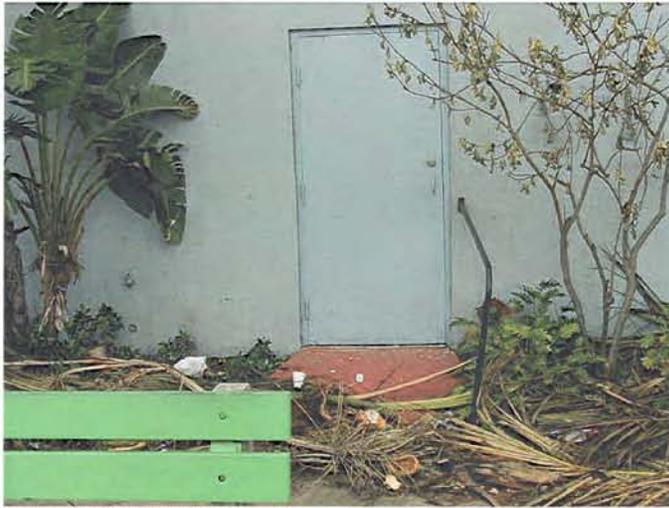
2.16 - NORTH SIDE – Door does not meet ADA.

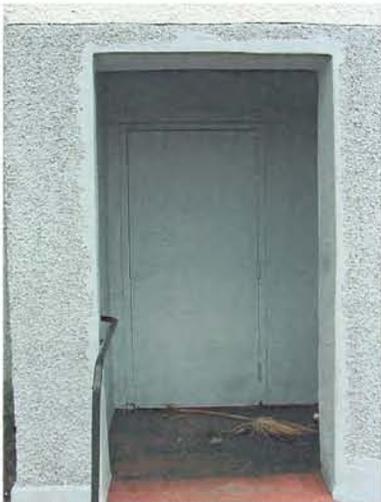
2.18 NORTH SIDE - Door does not meet ADA.

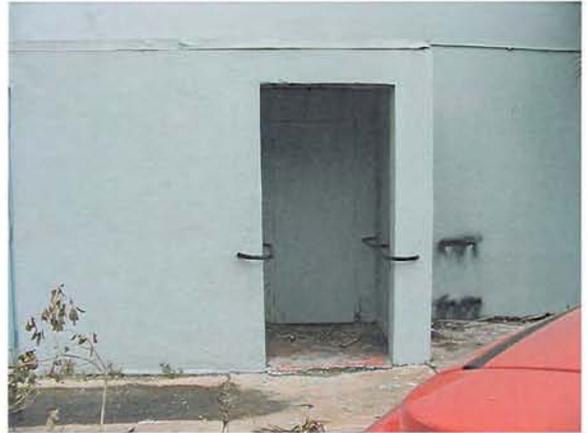
2.23 - SOUTH SIDE – Door does not meet ADA.

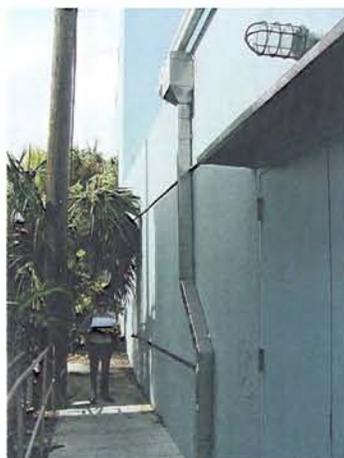
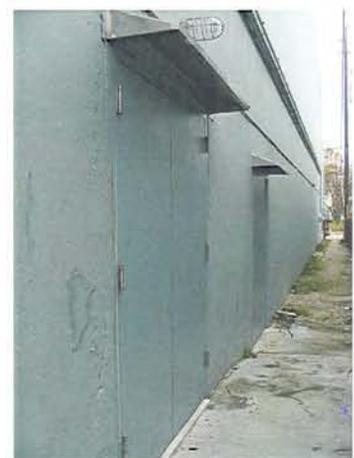
2.26 - SOUTH SIDE – Ramp and railings does not meet ADA.

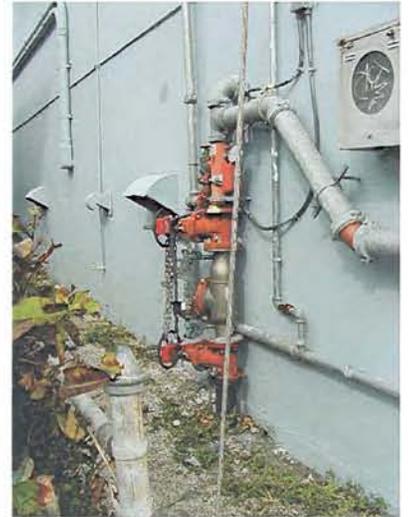
4.2

4.1 South east corner of building location of main electrical and mechanical room.

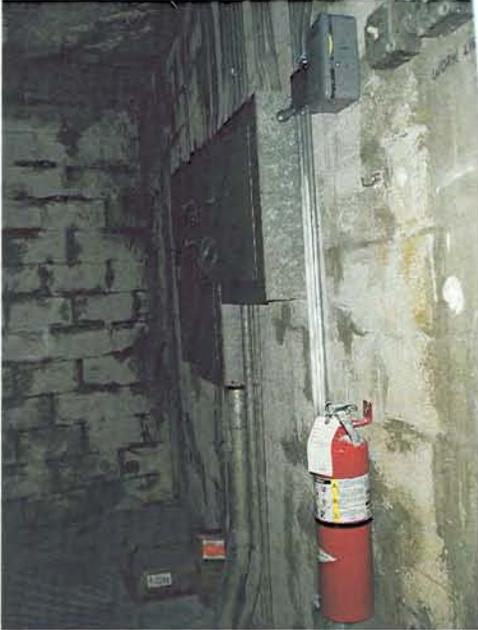
5.1

5.- EXISTING electrical room on ground level
South side of Building.

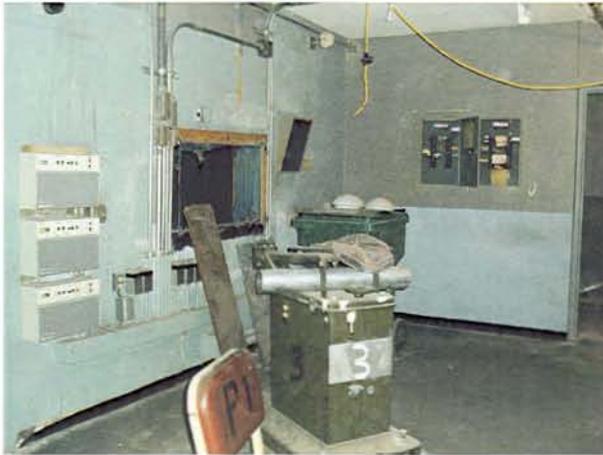
6.1

6.- **EXISTING CONDITIONS - Miscellaneous electrical panels**
West side - Second floor level in old projection room – Area connecting West and East Buildings

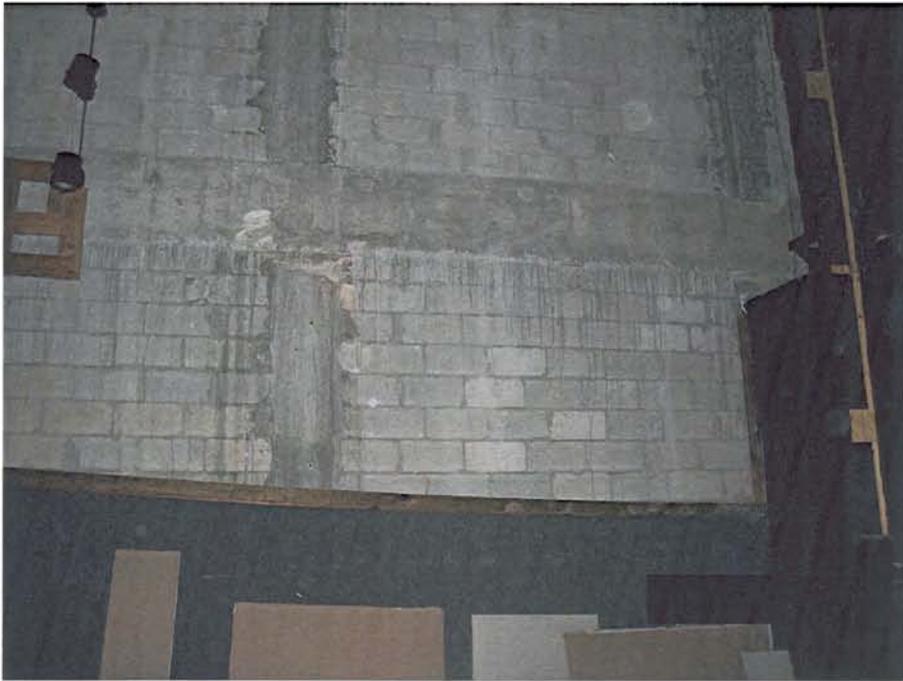
S3

STRUCTURAL VIEWS
Building Interior

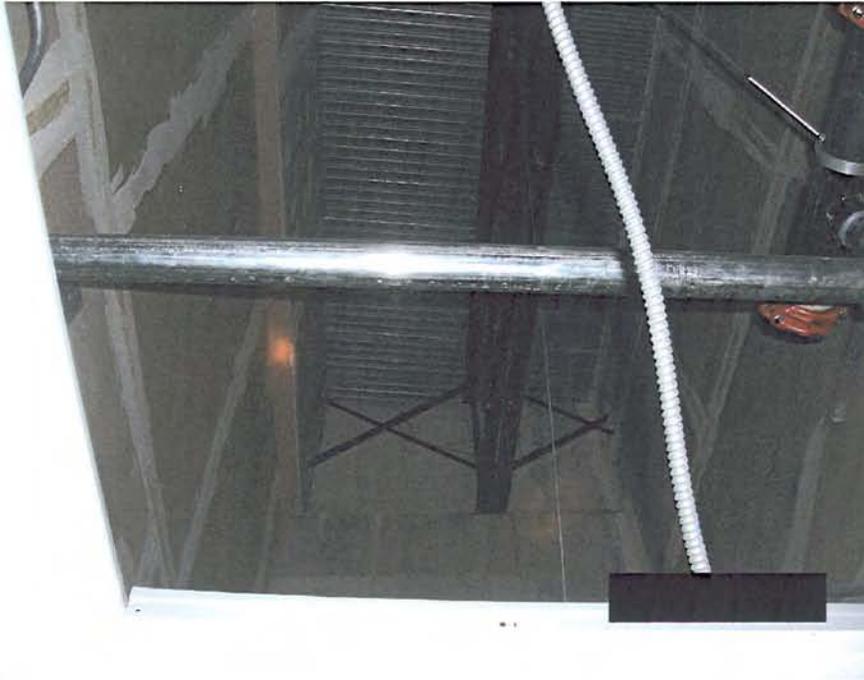
S5

STRUCTURAL VIEWS
Building Interior
